Bernalillo County
Environmental Health Department

**North Albuquerque Acres
Groundwater Quality Assessment**

March 2002

Report

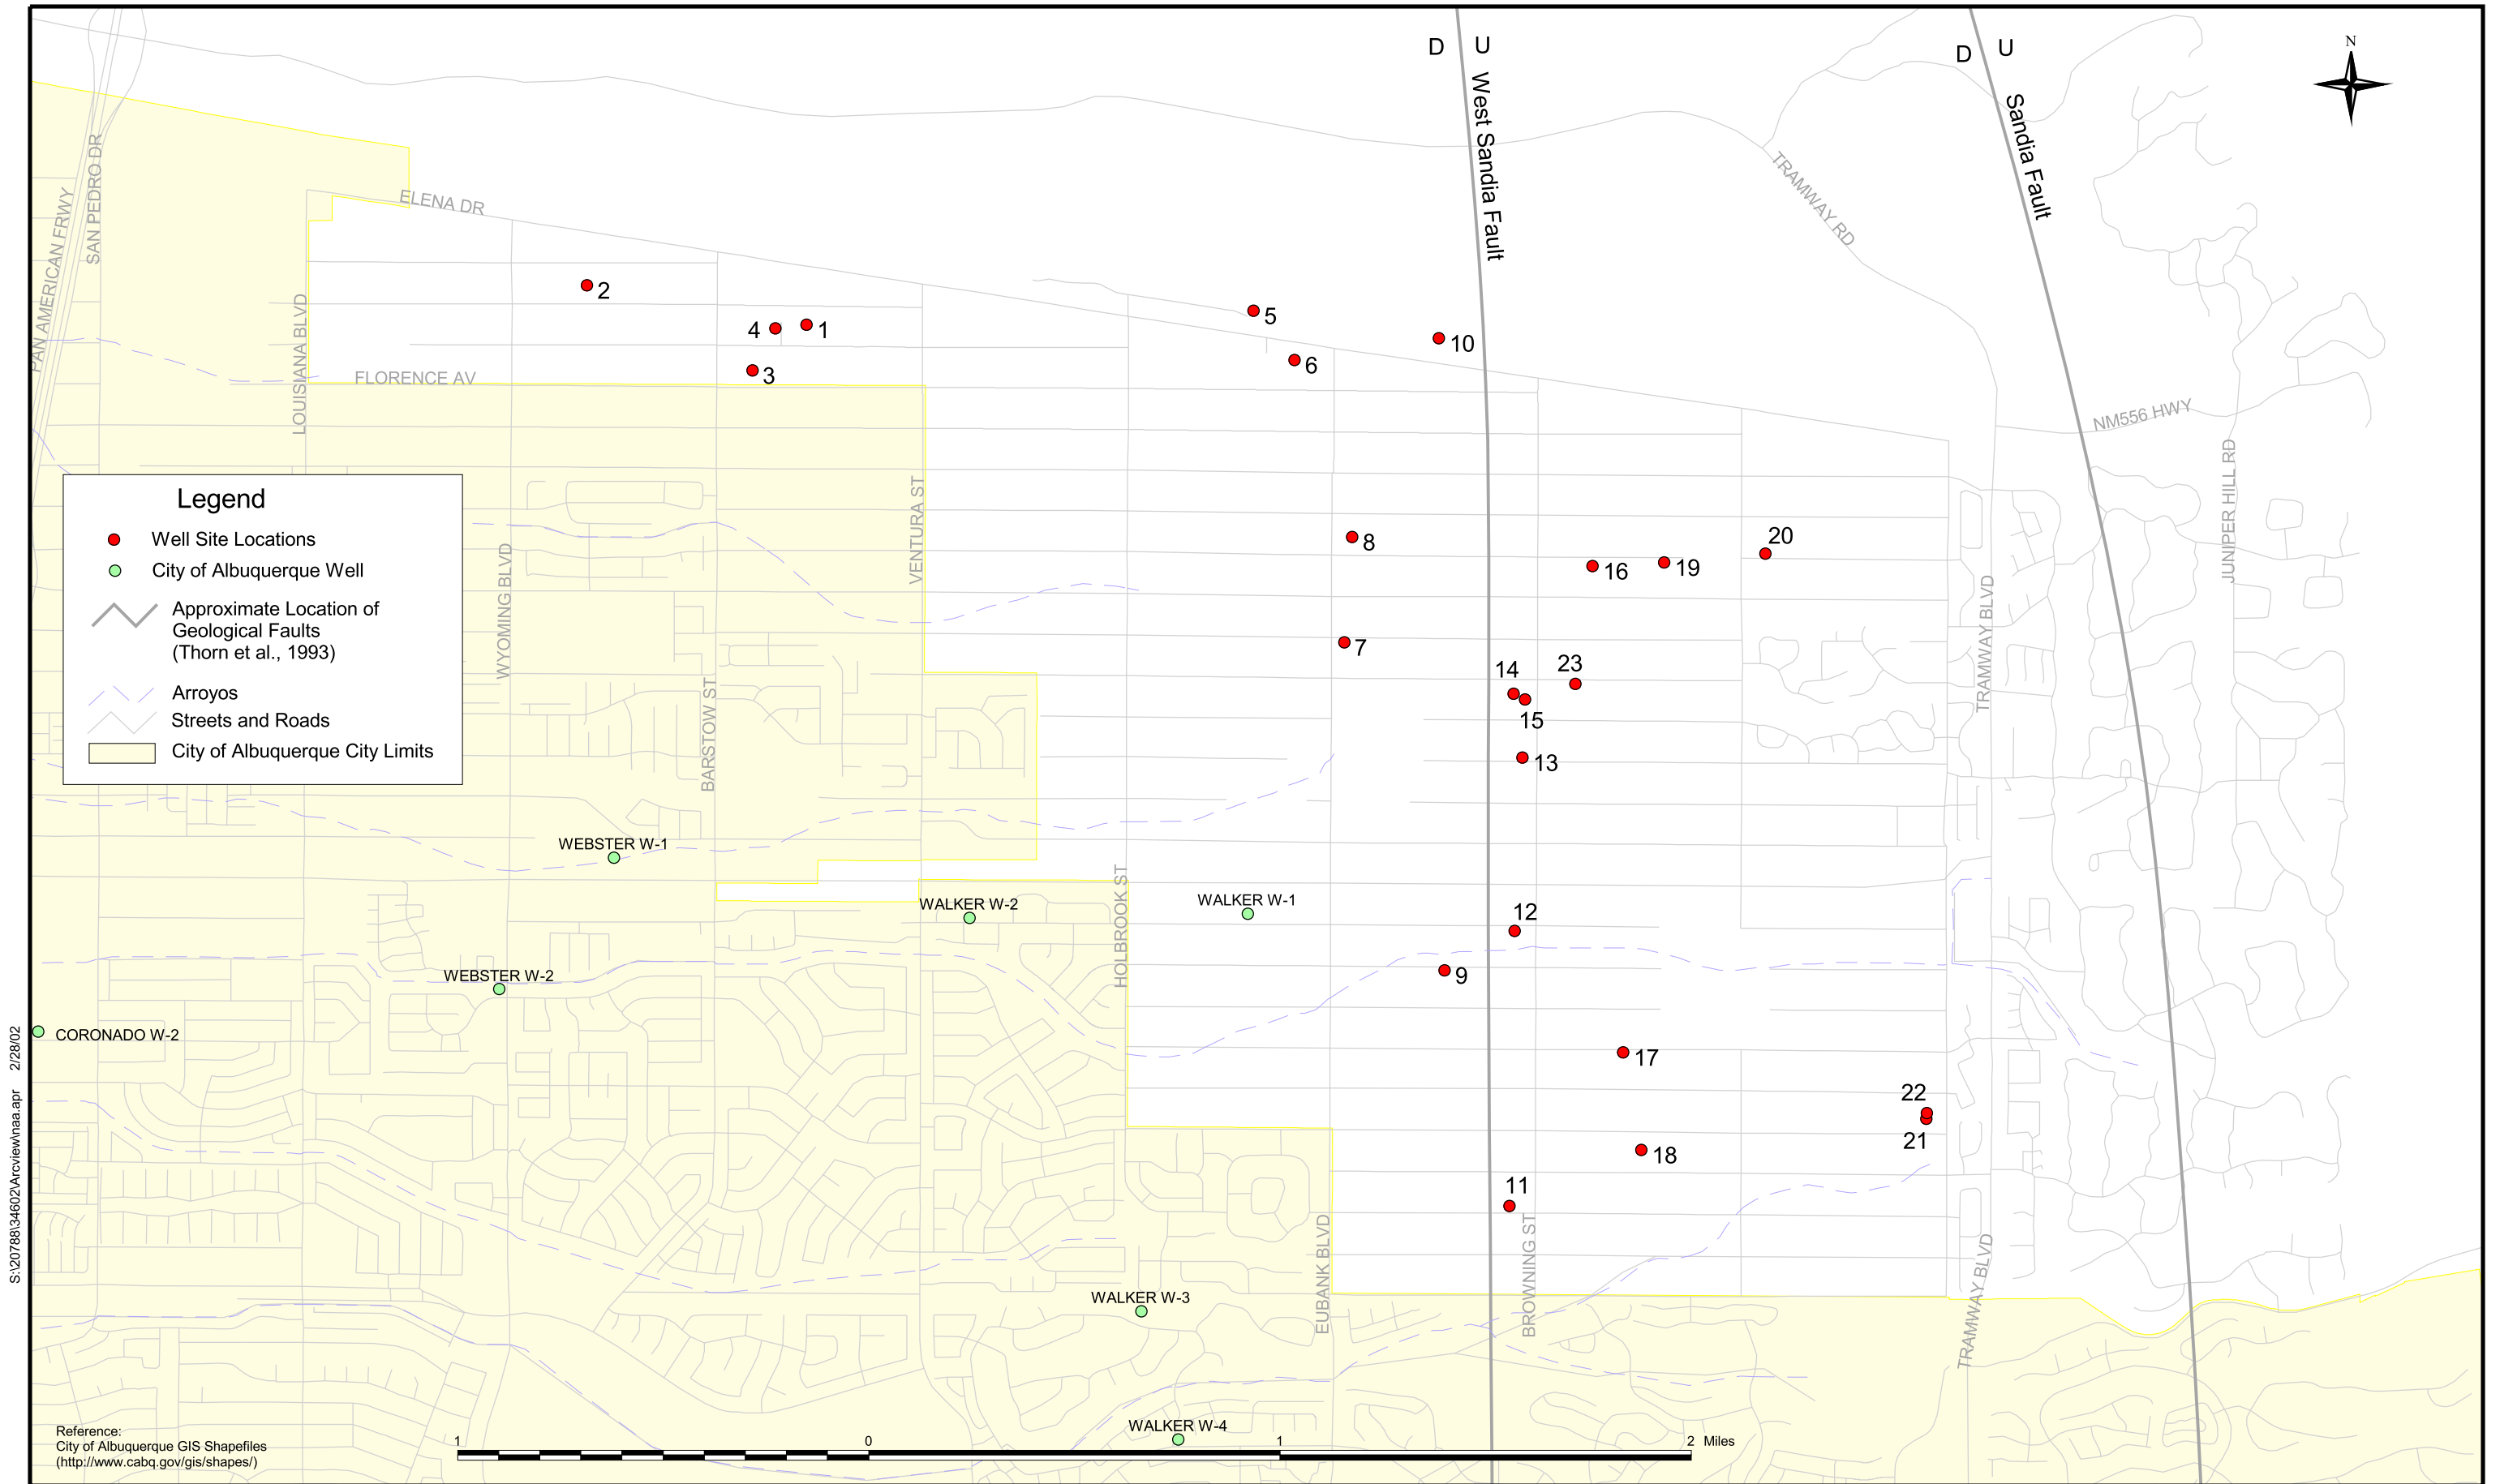
North Albuquerque Acres, Bernalillo County, New Mexico
Site Map
Figure 2

The finalized list summarizes the twenty-three participants and site numbers and is included as Table 2 (please note that the field notes were compiled using original site number designations). A sampling site location base map is included on Figure 2.

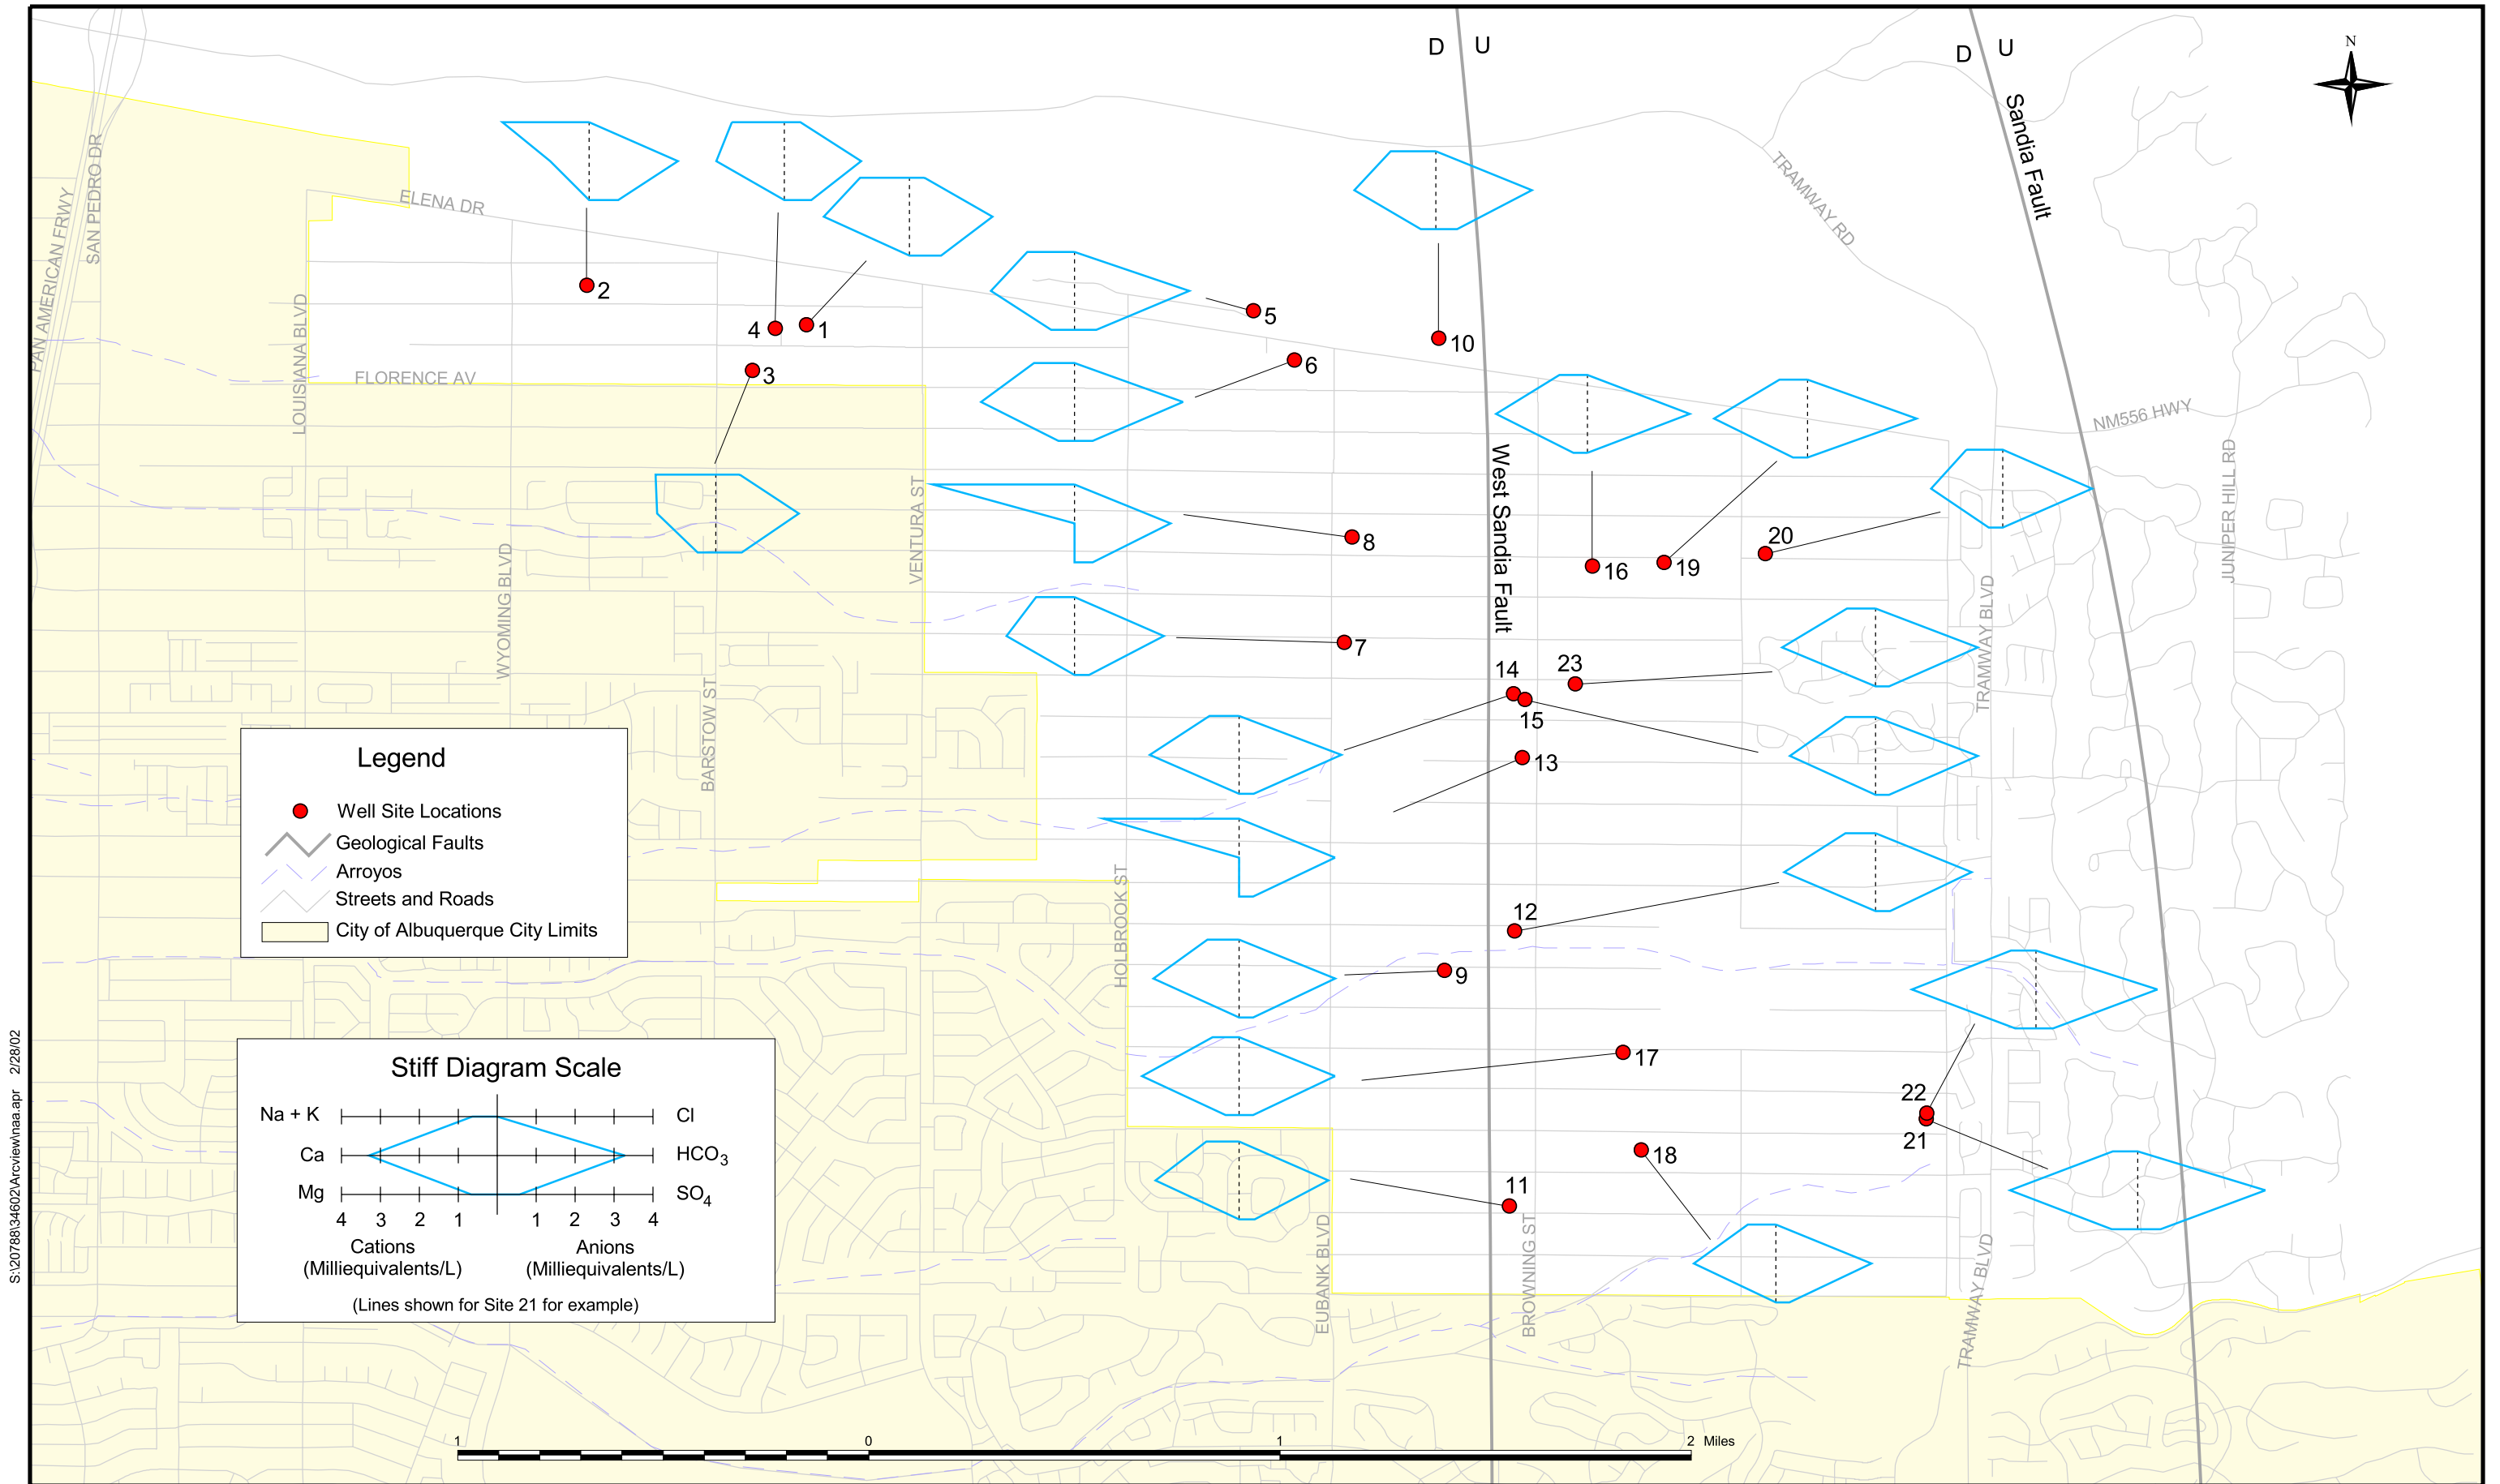
North Albuquerque Acres, Bernalillo County, New Mexico
 Groundwater Chemistry
 Figure 3

A graphical representation of the general water chemistry is summarized by the stiff diagrams superimposed over the site locations presented in Figure 2. These data clearly indicate that the water chemistry is generally consistent across NAA. In order to determine the hydrochemical facies, the water quality data were also plotted on trilinear diagrams (Figures 4 through 8). Hydrochemical facies are classified based on the dominant ions in the facies, which in turn are result of the lithology, solution kinetics and flow patterns of the aquifer (Fetter, 1988). The ionic chemistry indicates that the waters were of the calcium and bicarbonate types.

The exceptions are the samples collected from sites 8 and 13, which had very different cation chemistry. These samples were of the potassium type and bicarbonate type

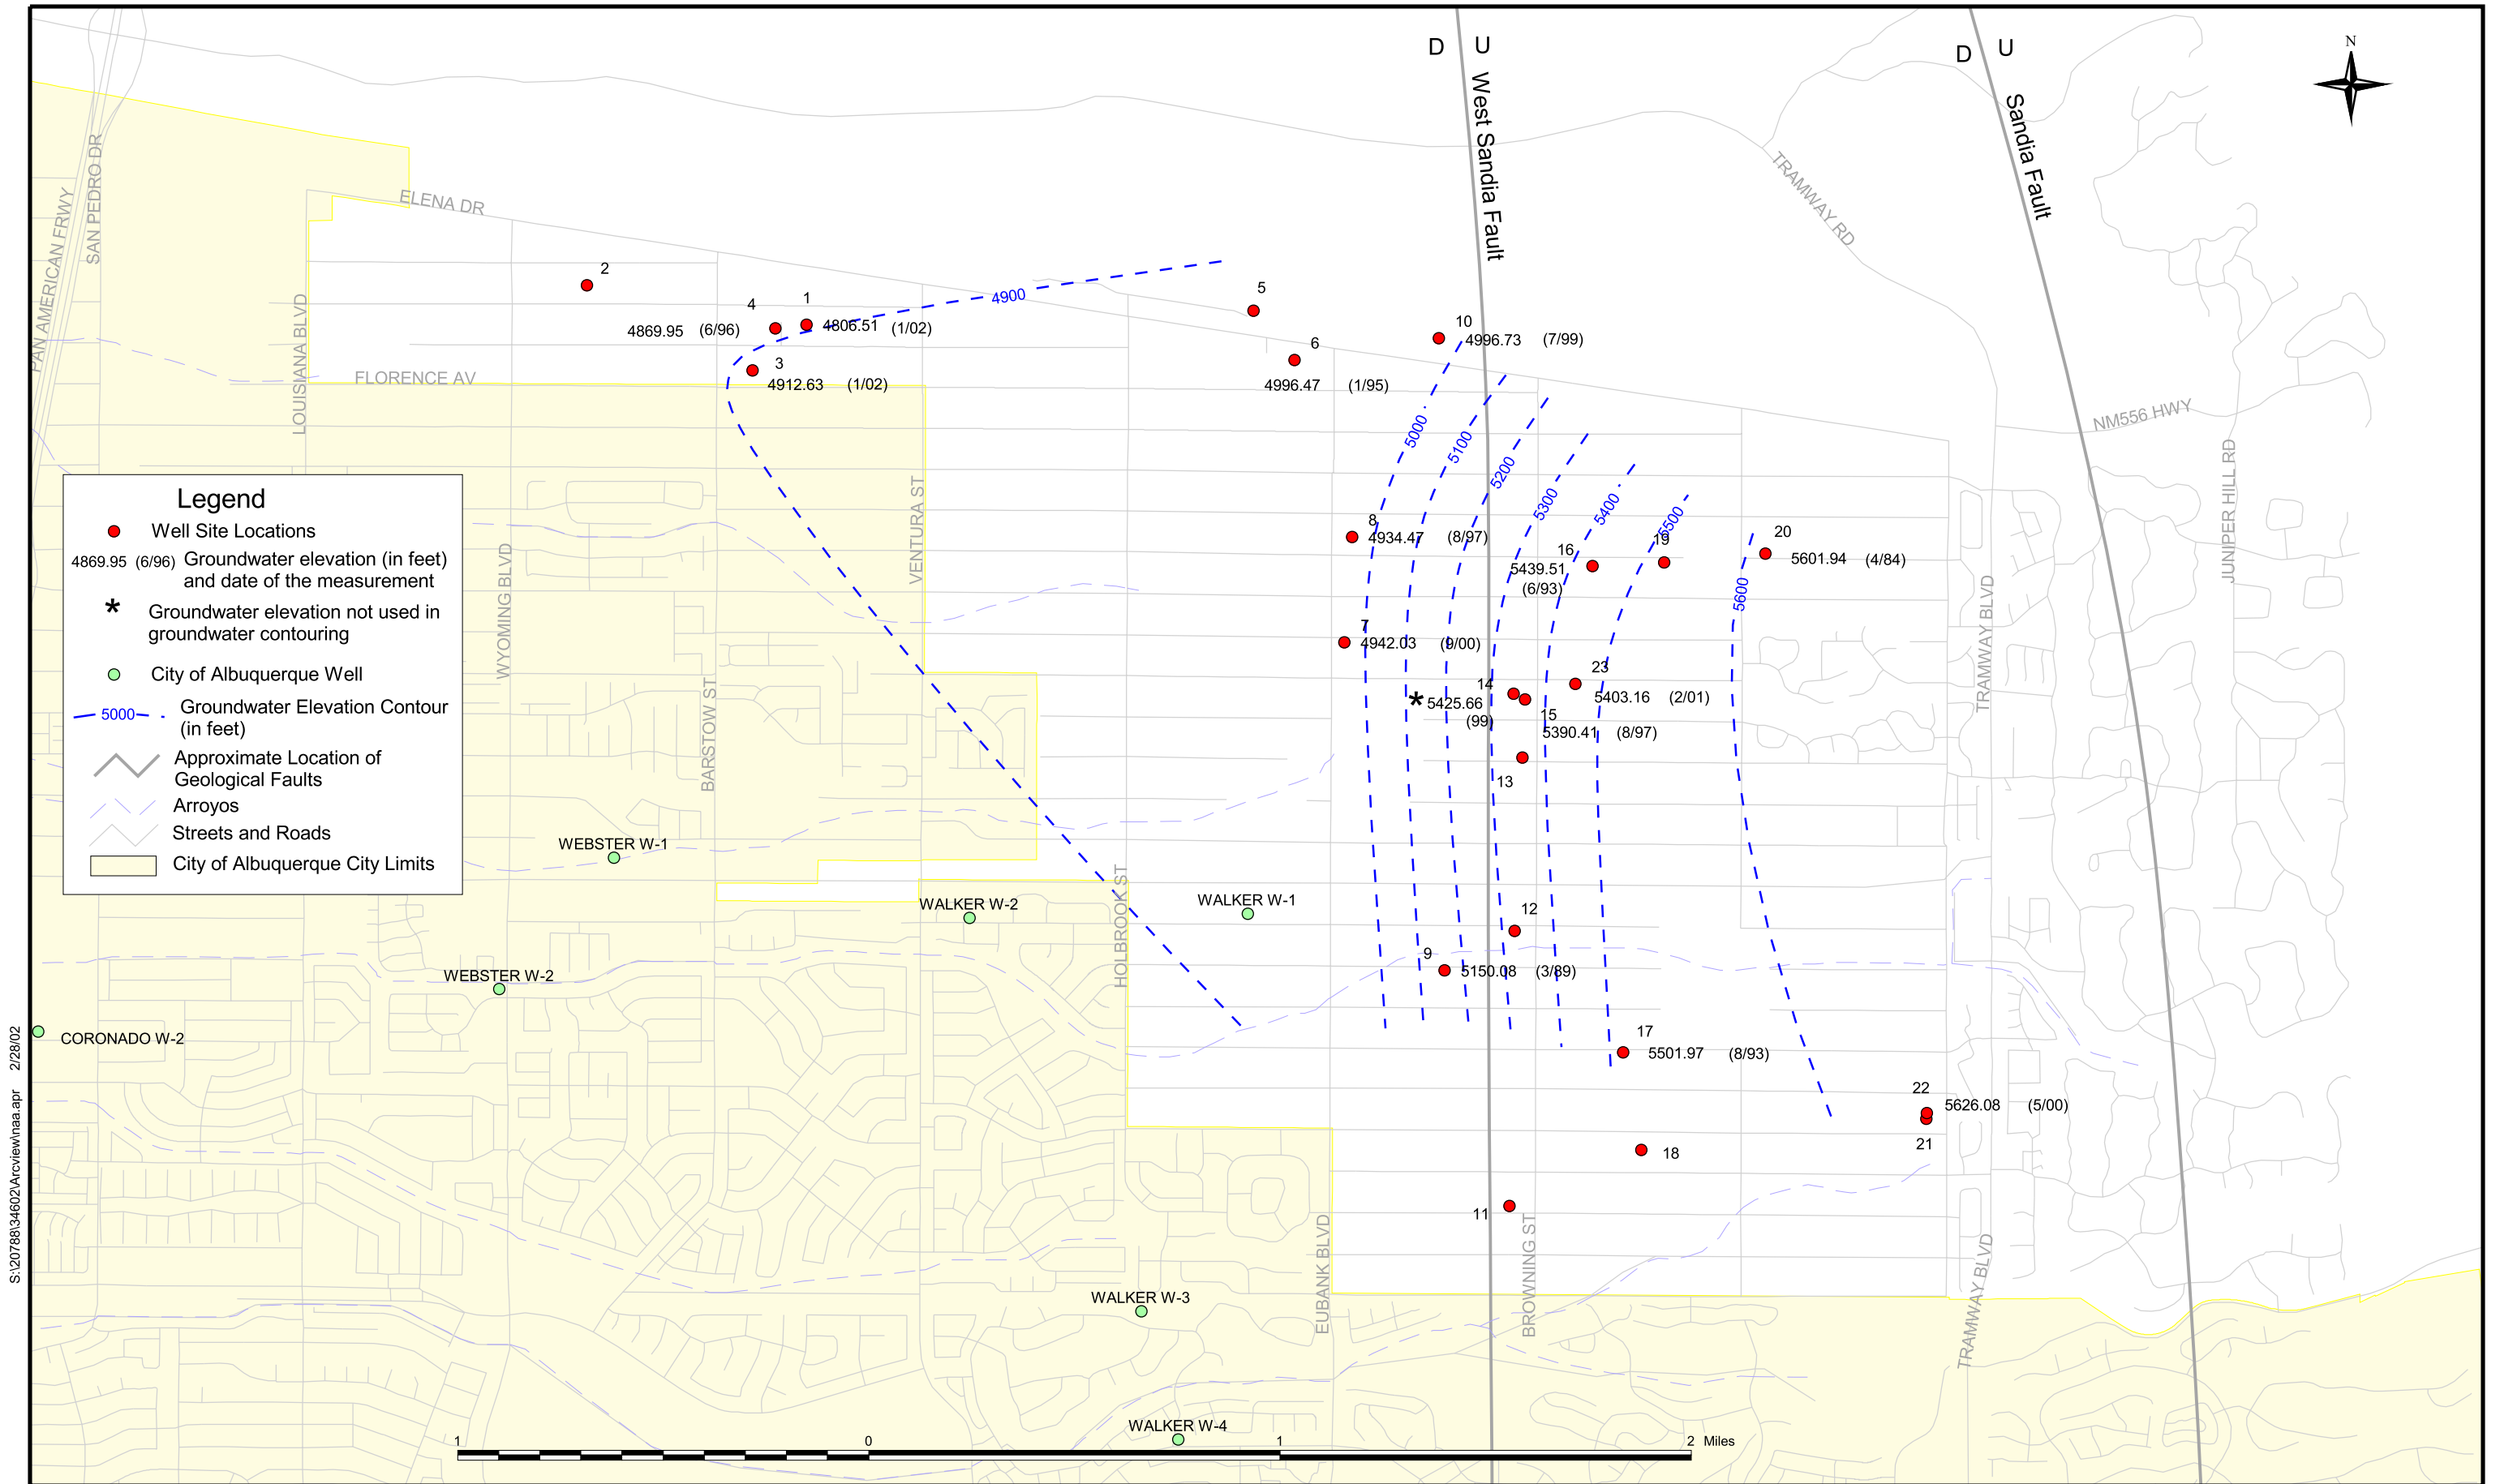
North Albuquerque Acres, Bernalillo County, New Mexico
Groundwater Contours
Figure 9

As part of this study, depth to groundwater measurements were made whenever possible and top of casing elevations were collected using a Starlink Invicta® 2105 APS receiver. However, due to the presence of the pumps, pumping, and power cords and the small diameter (generally 4 in.) of the wells, only three measurements were successfully made. These data were augmented with the depth to groundwater measurements collected upon completion of the wells and prior to the installation of the pumps, recorded on the Office of the State Engineer (OSE) well records (Appendix C) in order to generate a groundwater gradient map (Figure 9). Groundwater flow is generally to the west; however, flow in the southwestern portion of the study area appears to hydraulically influenced by the pumping of the City of Albuquerque Webster and Walker well fields. The calculated hydraulic gradient across the study area is approximately 0.04 ft/ft. However, much of the drop in water table elevation occurs across the west Sandia Fault where groundwater elevation are at least 350 feet lower on the down thrown side of the fault. The depth to groundwater in the study area ranges from 355 ft. to 830 ft. with an average depth to groundwater of approximately 576 feet below surface grade (bsg). The location, elevation and depth to groundwater data are included in Appendix D.
